TECHNICAL NOTE 3275

INVESTIGATION OF THE EFFECT OF IMPACT DAMAGE ON FATIGUE
STRENGTH OF JET-ENGINE COMPRESSOR ROTOR BLADES

By Albert Kaufman and André J. Meyer, Jr.

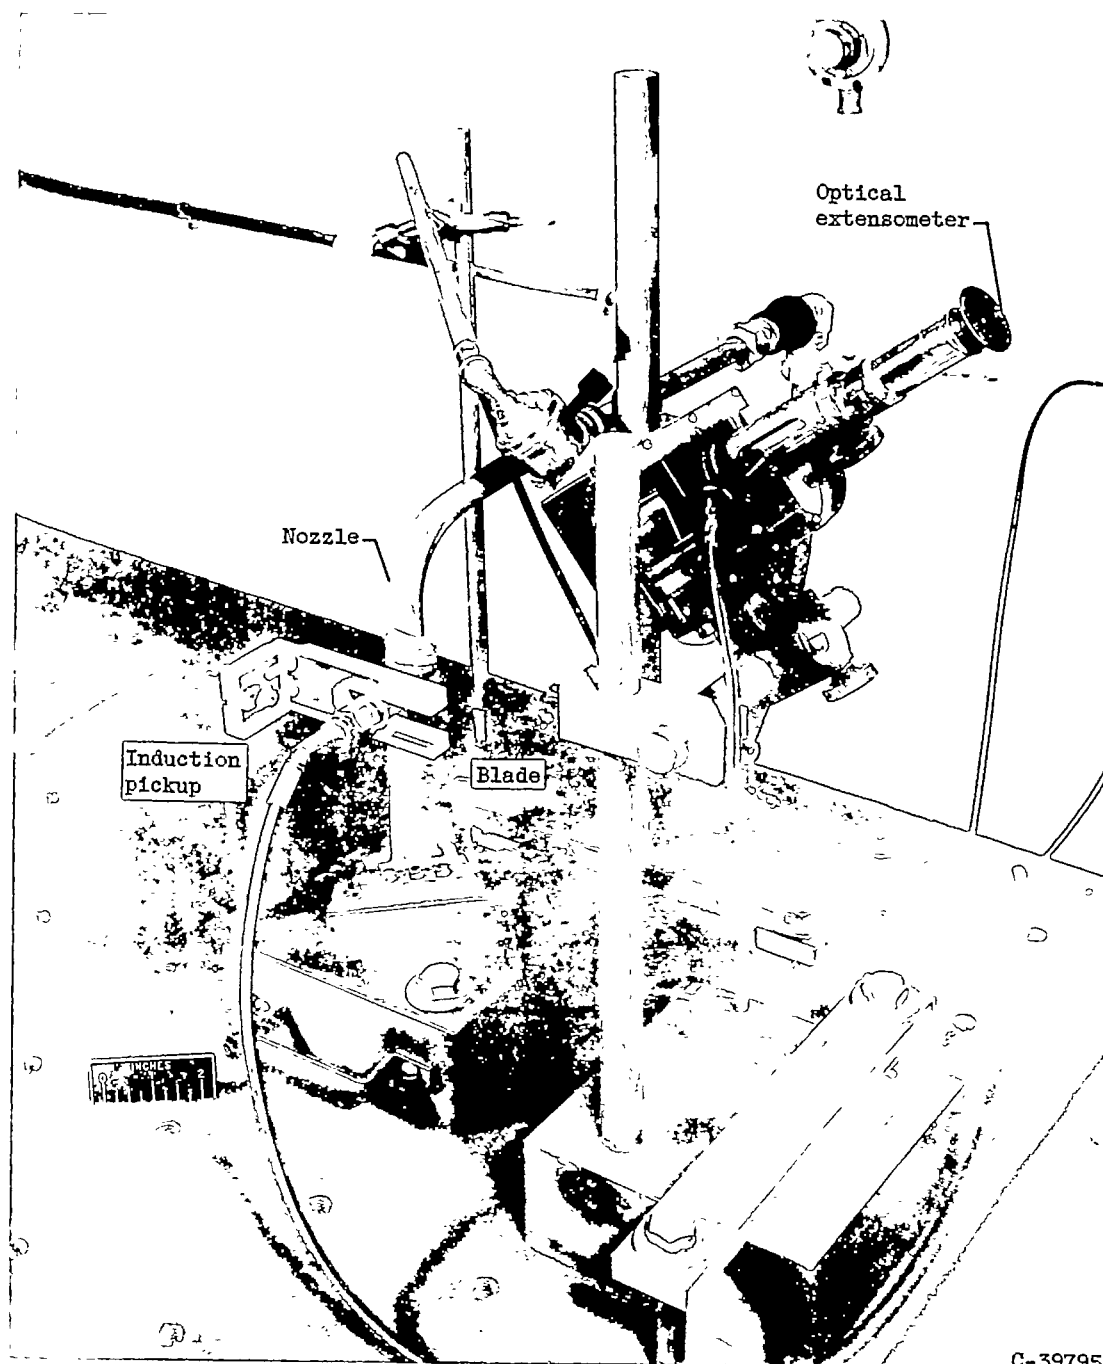
Figure 3. - Apparatus for fatiguing blades.

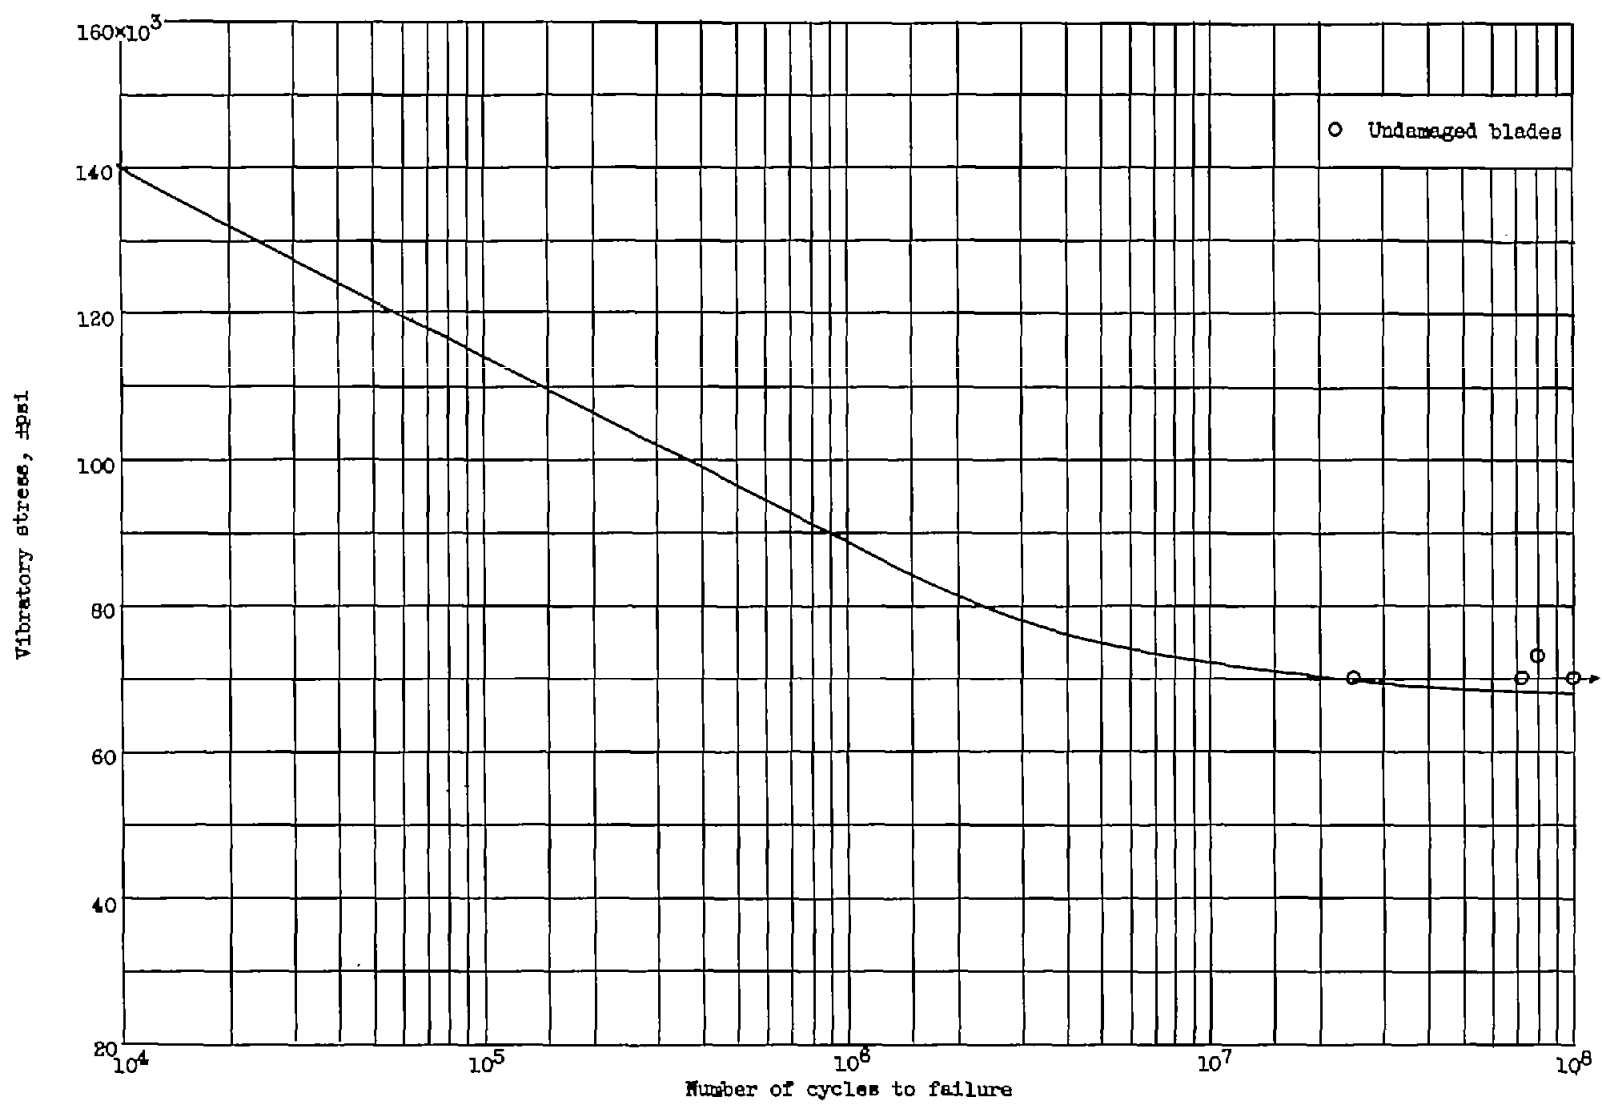
The highest strength-reduction factor computed for these tests is 1.8 (fig. 6). This fact would indicate that if the vibratory stresses could be kept well below $\pm 38,000$ psi ($70,000$ psi/1.8) for all blades at

Figure 6. - Blade life as a function of vibratory stress.

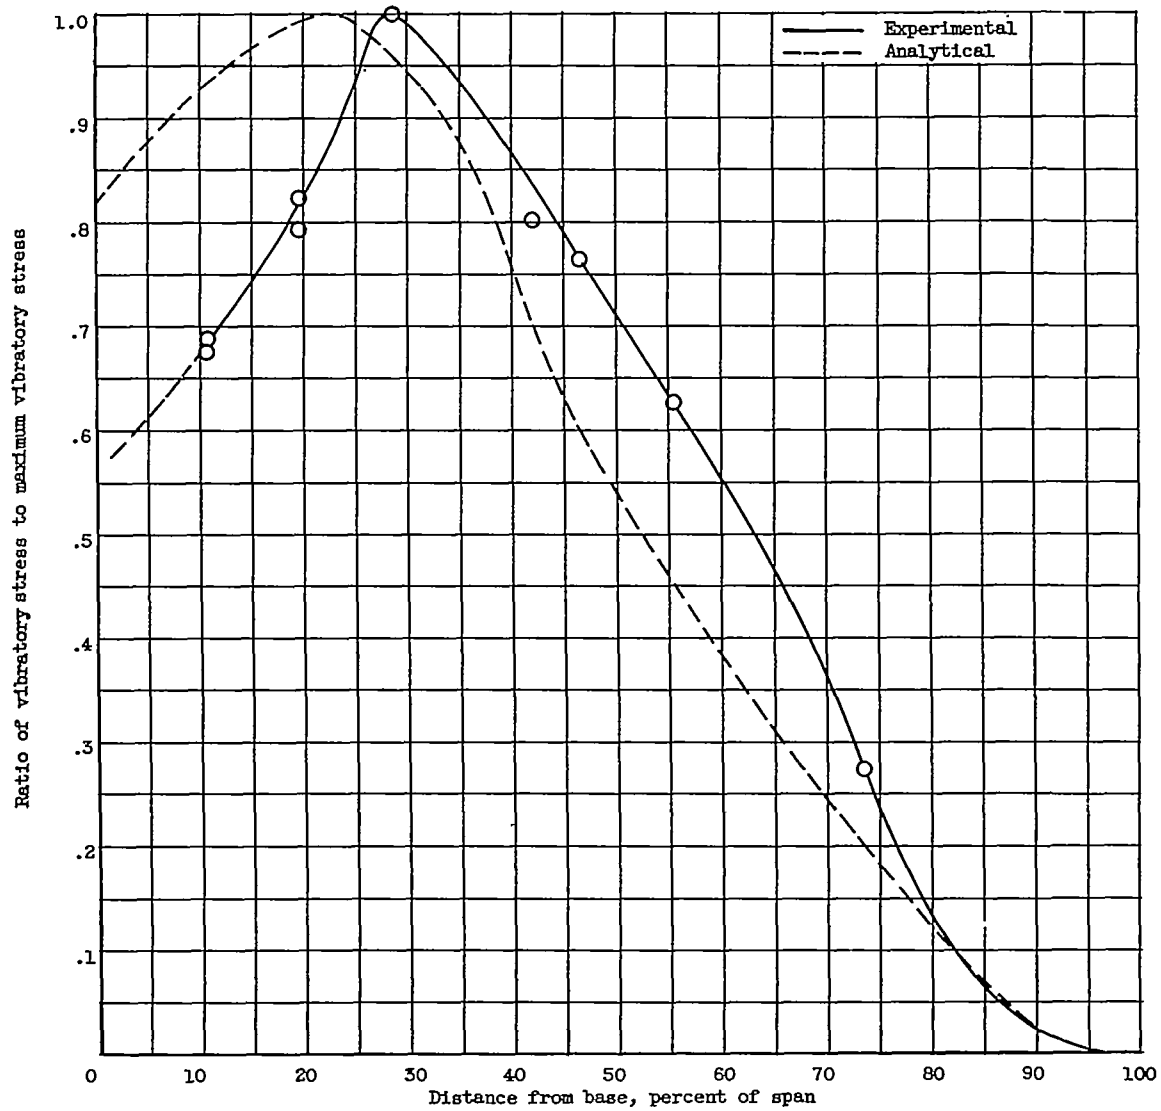
obtained from the strain-gage measurements is also shown in figure 7. The critical section on this curve is at about 28.5 percent of the span from the base. Since the analytical curve was determined for the maximum-stress point at every section, which sometimes occurred on one of the edges, the two curves of figure 7 were not expected to agree perfectly. The stresses at the blade edges were not measured because of the difficulty of mounting the gages at these points.

3356 A blade, which except for the tip region was initially undamaged, was fatigue tested to failure to determine the failure location (fig. 8). In this blade the crack started at the thickest part of the section on the suction surface. In other undamaged blades, failure started at the leading edge. The spanwise location of failure, regardless of where the failure started chordwise, was always about 30 percent of the span from the base of the airfoil. Both the analytical and measured stress distributions of figure 7 satisfactorily predict the critical section, the experimental curve giving the closest prediction.

Figure 7. - Airfoil vibratory-stress distribution.
